NOTE 30

ASI5700, ASI5800, ASI6700 Computer Compatibility

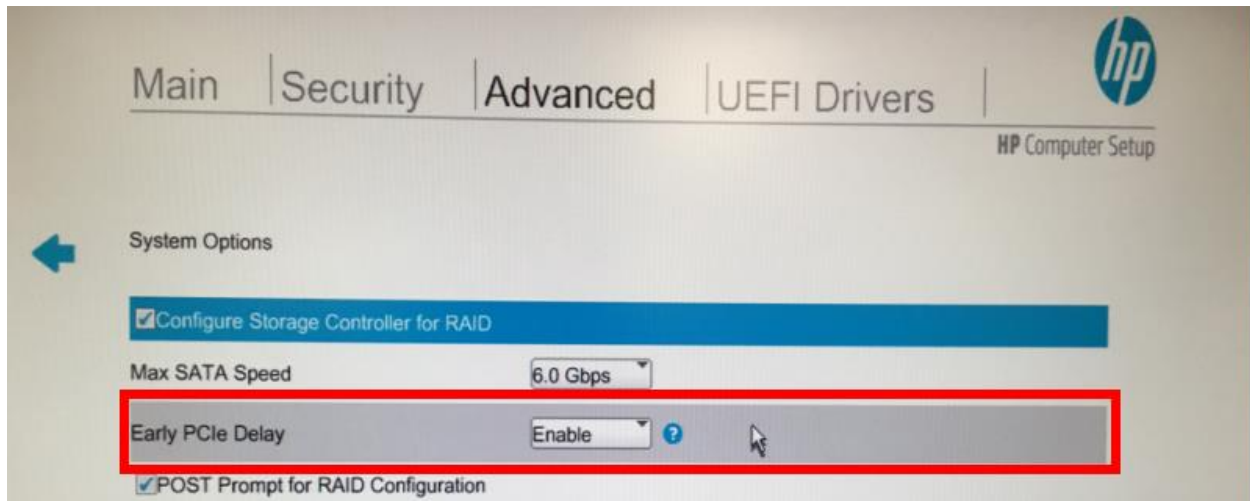
2.1 HP z240

ISSUE: The soundcard will not be initialized by the computer and will not be “seen” by the AudioScience drivers. The LEDs on the top of the card will continuously flash about once every 2seconds.

FIX: The BIOS of the z240 has a setting under Advanced called Early PCIe Delay. The default value of this is Disabled. It must be set to Enable in order for the sound card to be recognized and the AudioScience drivers loaded correctly.

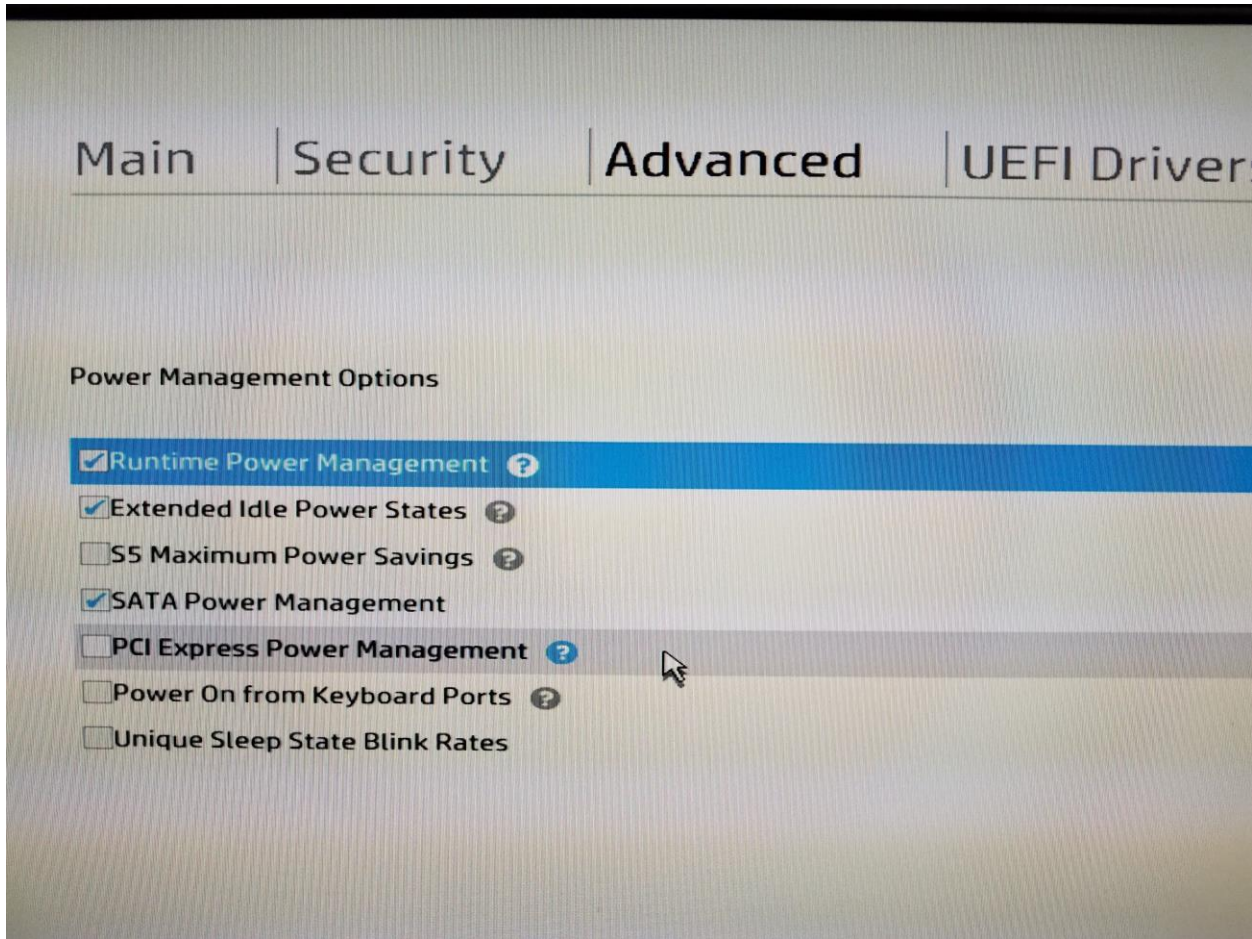
2.2 HP EliteDesk 800 G3

ISSUE: Cards will function properly for some time but may drop off the system unexpectedly. Often they will show in ASIControl as ASI#0000 or Adapter Unavailable. This may also create a large number of “Microsoft-Windows-WHEA-Logger” errors in Windows Event Viewer.

FIX: The BIOS of the EliteDesk series (and possibly other HP systems) has a setting that allows it to manage the power settings of the PCI(e) bus. These options are incompatible with the chips used on our cards. We recommend you turn off this setting in the system BIOS. Go to the Advanced tab -> Power Management Options -> PCI Express Power Management and turn it off (unclick it). Then reboot your system.
